# HAZARD SAFETY AUDIT

Bursledon Parish Council

Site: Pilands Wood Open Space

March 2022  
CBA11336PW v1

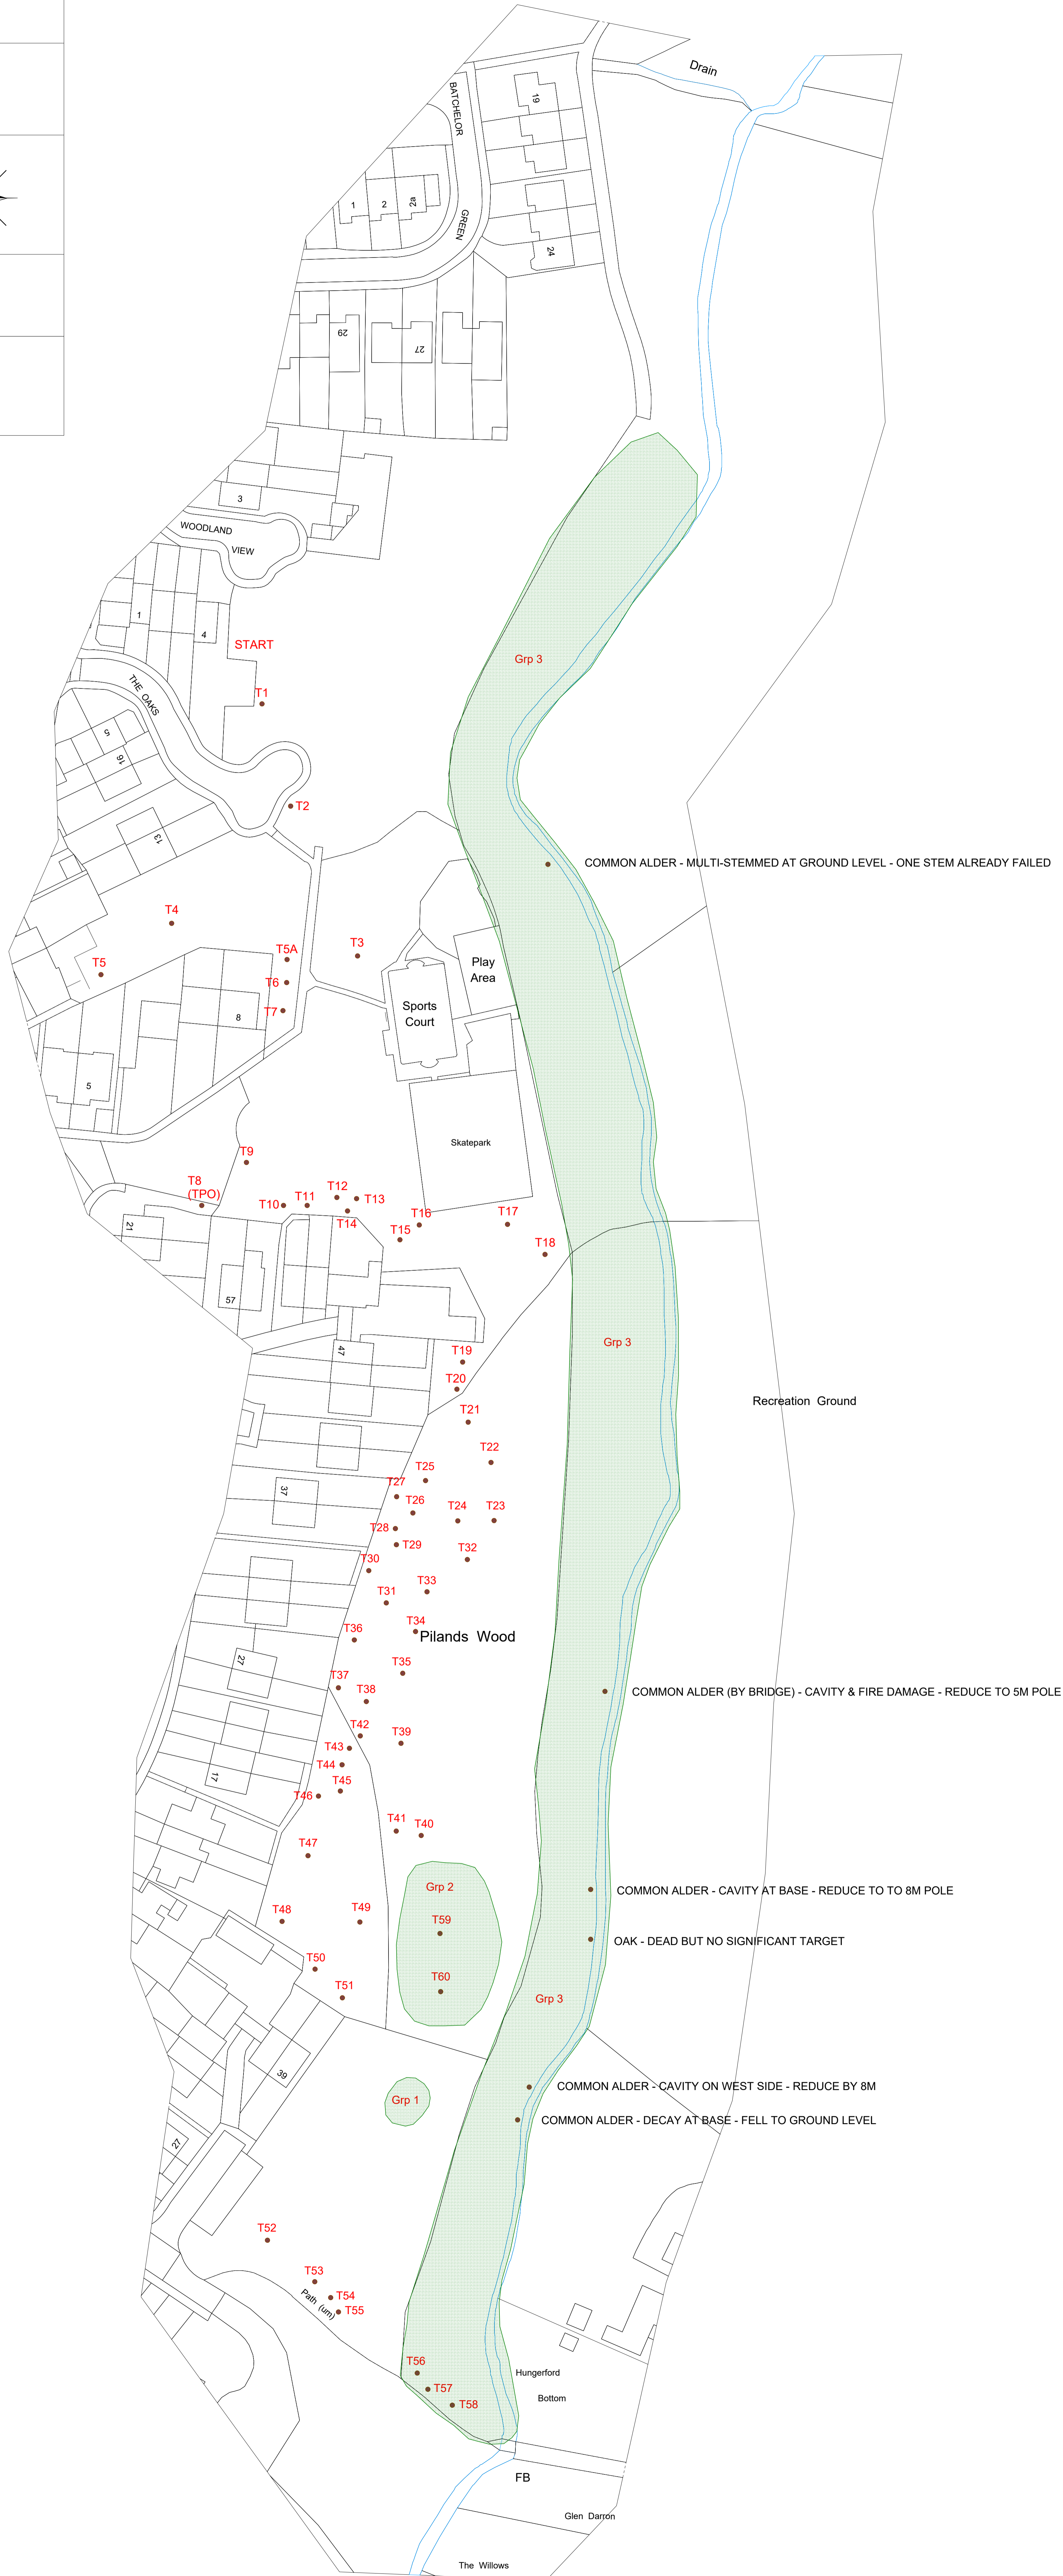
**CBA11336PW**  
**Pilands Wood Open Sapce, Bursledon**  
**Tree Location Plan**

COMMON ALDER - MULTI-STEMMED AT GROUND LEVEL - ONE STEM ALREADY FAILED

COMMON ALDER (BY BRIDGE) - CAVITY & FIRE DAMAGE - REDUCE TO 5M POLE

COMMON ALDER - CAVITY AT BASE - REDUCE TO TO 8M POLE

OAK - DEAD BUT NO SIGNIFICANT TARGET

COMMON ALDER - CAVITY ON WEST SIDE - REDUCE BY 8M

COMMON ALDER - DECAY AT BASE - FELL TO GROUND LEVEL
